# Manhole Inspection Summary

Manhole # S15E\_\_011MH

Insp Date: **5/26/09 3:16 PM**

**Location** Address: **2800 W SARATOGA ST**

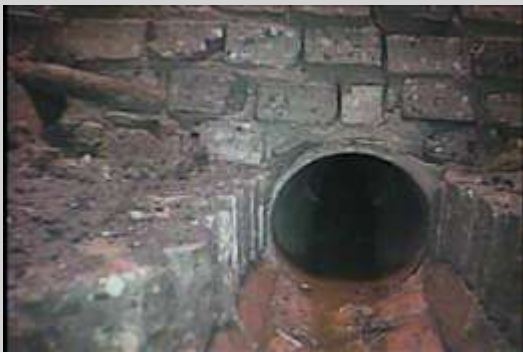
12 O'Clock Outflow

8 in. Circular Gravity Sewer  
Pipe Out @ 12 O'Clock

Infiltration: **None** Pipe Seal Cond: **Sound**
